## HLH ROTOR BLADE MANUFACTURING TECHNOLOGY DEVELOPMENT REPORT

Boeing Vertol Company  
P. O. Box 16858  
Philadelphia, Penn. 19142

September 1977

Final Report

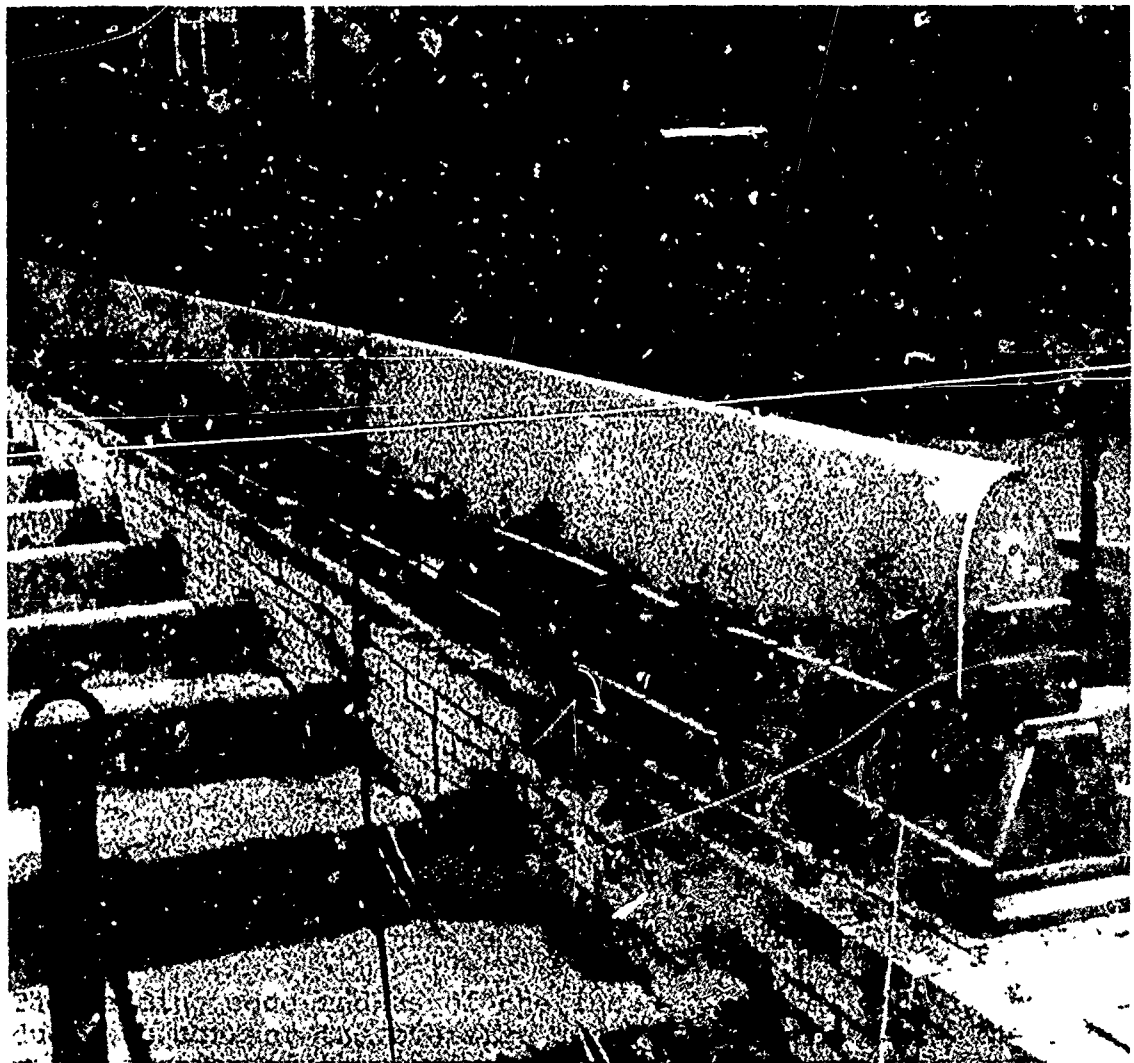
*Figure 27. Formed Titanium Cap*

1. Form of radii at L.E. was oversize
2. Outboard section from Station 469.2 to the tip (Station 552) had a chordwise bow.
3. Buckles and caves in the outboard area

The leading edge radius of the Inconel mandrel will be reduced to correct the oversize condition on the cap. The out-board section of the mandrel is to be moved chordwise approximately 0.150 inches to correct the bow; better control of expansion (part vs. tool) should help remove the buckles and caves.

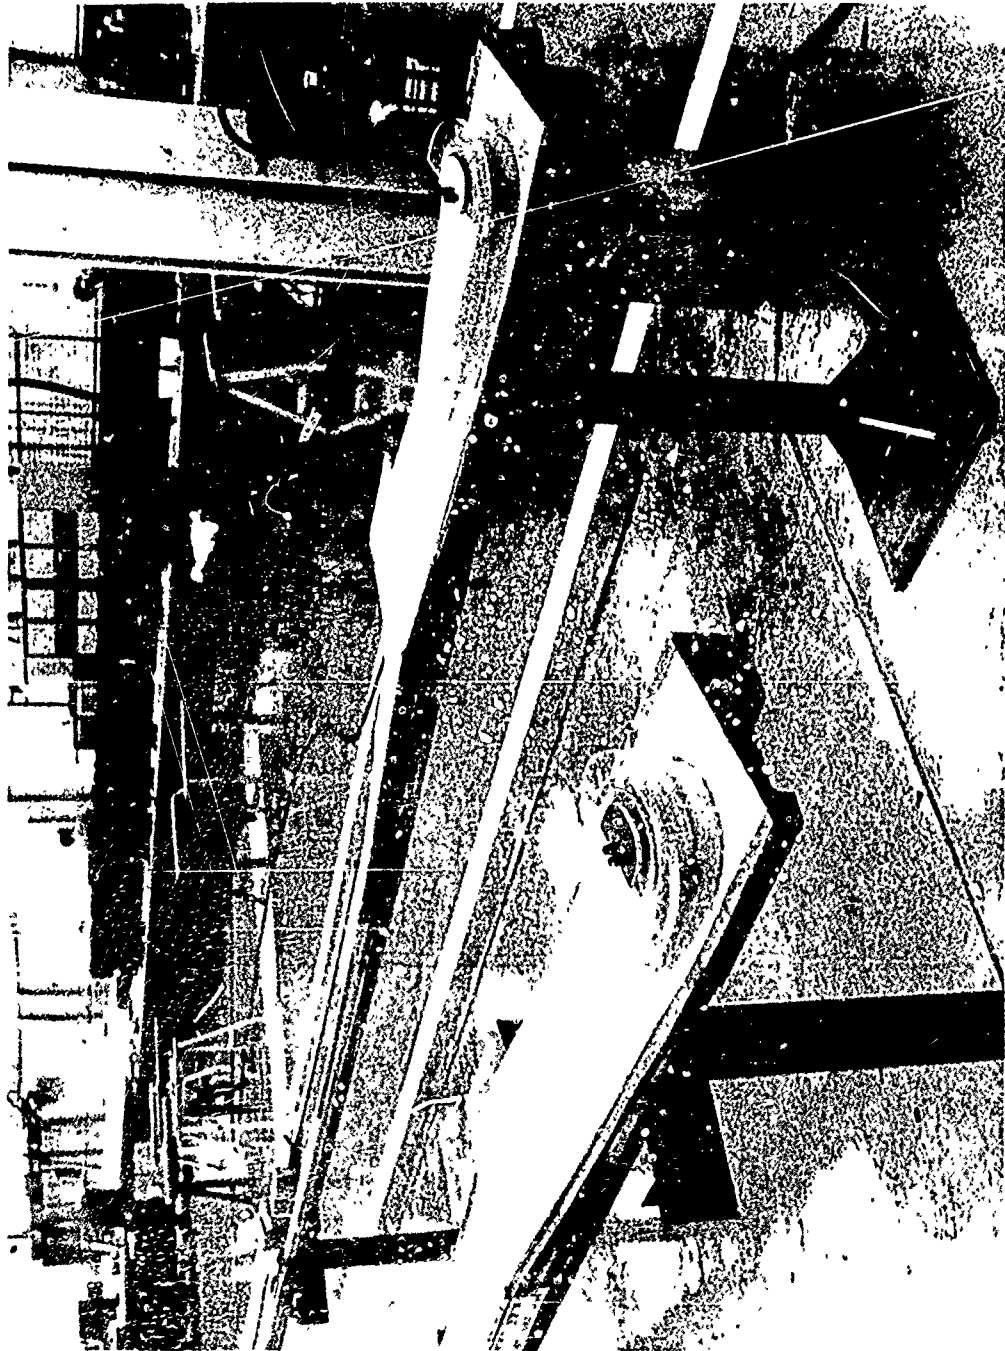
*Figure 28. Two of Four Spar Strap Subassemblies*

For any composite product to be successful, the lay-up operation is the key. To ensure using the proper number of plies and their correct orientation, tools of minimum complexity were provided to the shop. Tools were made for the following parts: leading-edge spar fillers (2), spar straps (4), and trailing-edge wedge (1). These parts are relatively flat; the prime purpose of the tool, therefore, was to control width, number of plies, and ply drop-off or location. It should be noted that the spar straps and leading-edge fillers each contained approximately 95 plies of Uni-Fiberglass. This was done so that, in addition to controlling plies, the tools also provided a means for the mechanic to compact the material, with Teflon rollers, to eliminate as much of the trapped air as possible. It also reduced the overall mass of material, which aided in the next assembly and cure operation. See Figure 28.

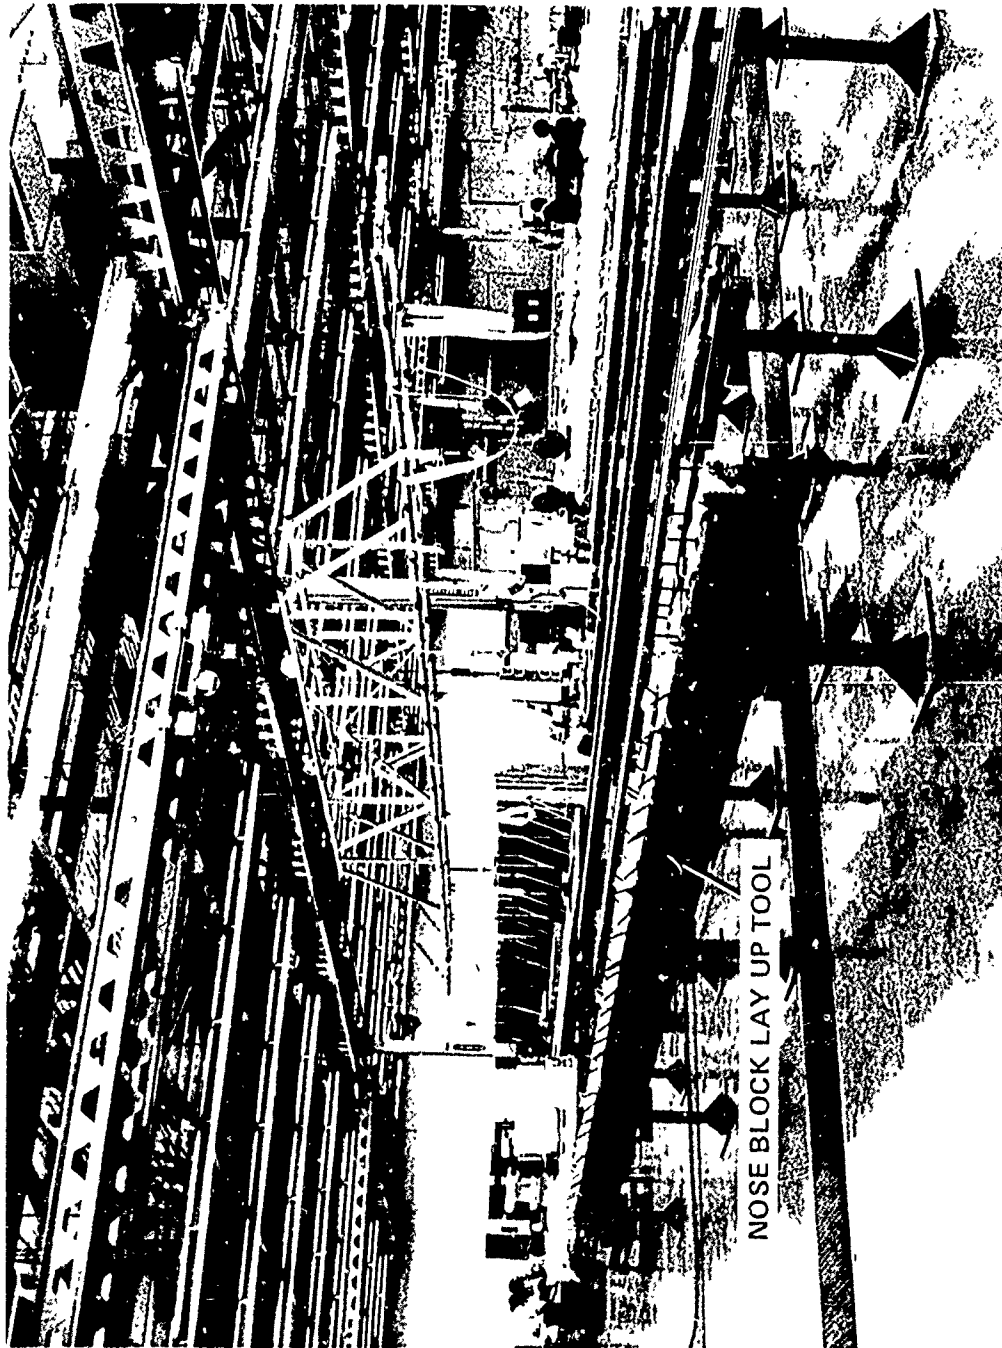
Figure 29. Nose Block Lay-Up Tool

The spar nose block required a more elaborate tool than those described above, due to airfoil shape and the requirement to locate the leading edge weight rods (Figure 29). This was accomplished by making a two-stage tool which produced the first half of the nose block (to the centerline of the weight rod) and then the aft portion using a second compaction tool. Refer to Figure 30 for nose block tooling details.

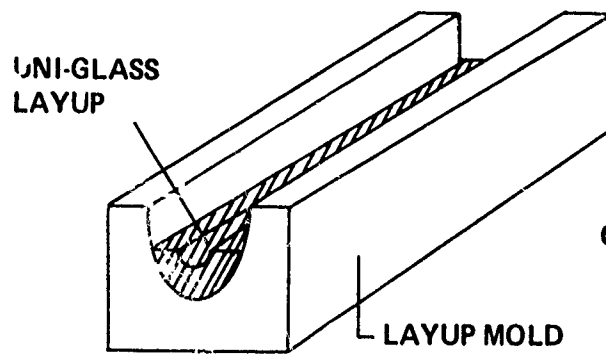
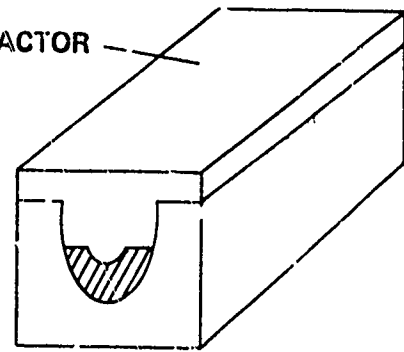
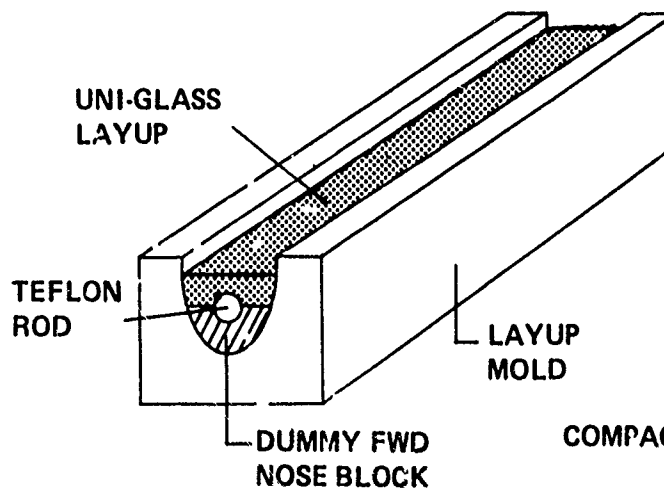
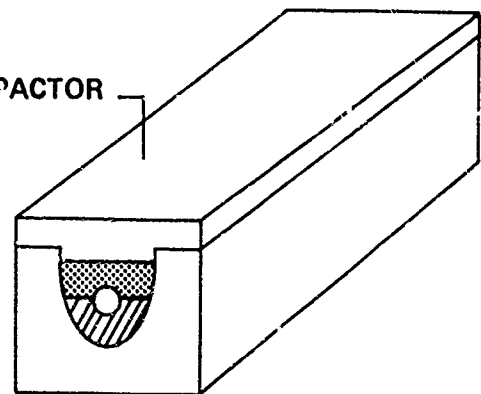
Figure 30. Nose Block Tooling

### FWD NOSE BLOCK

### AFT NOSE BLOCK

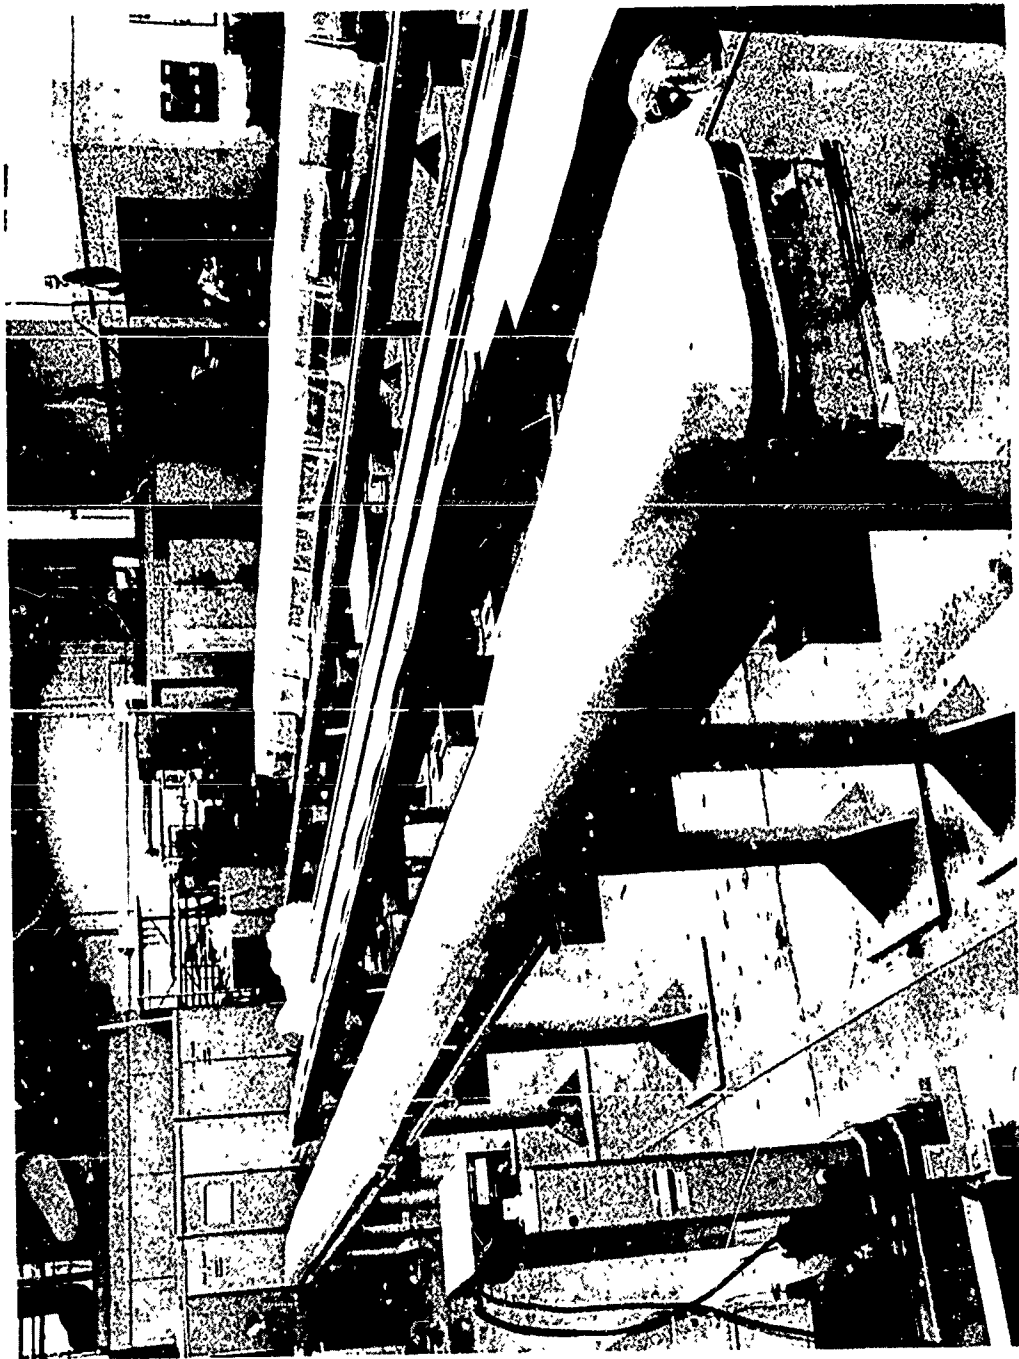
*Figure 31. Outer Torsional Wraps — Lay-Up and Trimming Operations Completed and Ready for Use on Spar*

Other details, such as the spar inner torsion wrap, the blade skins and others that did not have too many plies or were simple in configuration, were controlled by use of templates. One exception is the tool for outer torsion wrap; it consists of eight plies at the root end and reduces to one ply at the tip. Since it is the outer member of the spar, it is the last item to be assembled to the spar lay-up prior to installation of the titanium cap. If contour and overall size of the outer torsion wrap is not held during lay-up and installation on the spar, location of the complete uncured spar into the bonding fixture then becomes a difficult task and could cause wrinkles or voids in the cured spar. The outer torsion wrap for the first spar was laid-up using both halves of the spar BAJ. This method was acceptable; however, it required additional time spent in the BAJ which was already overloaded. In addition, it was found to be more desirable for shop personnel to lay-up the fiberglass on a male tool rather than on a female tool such

as the BAJ. A male mandrel (two-piece upper airfoil and lower airfoil) was made from a foam material, mounted on a common base, and covered with plastic coating to give a hard working surface. This is illustrated in Figure 31.

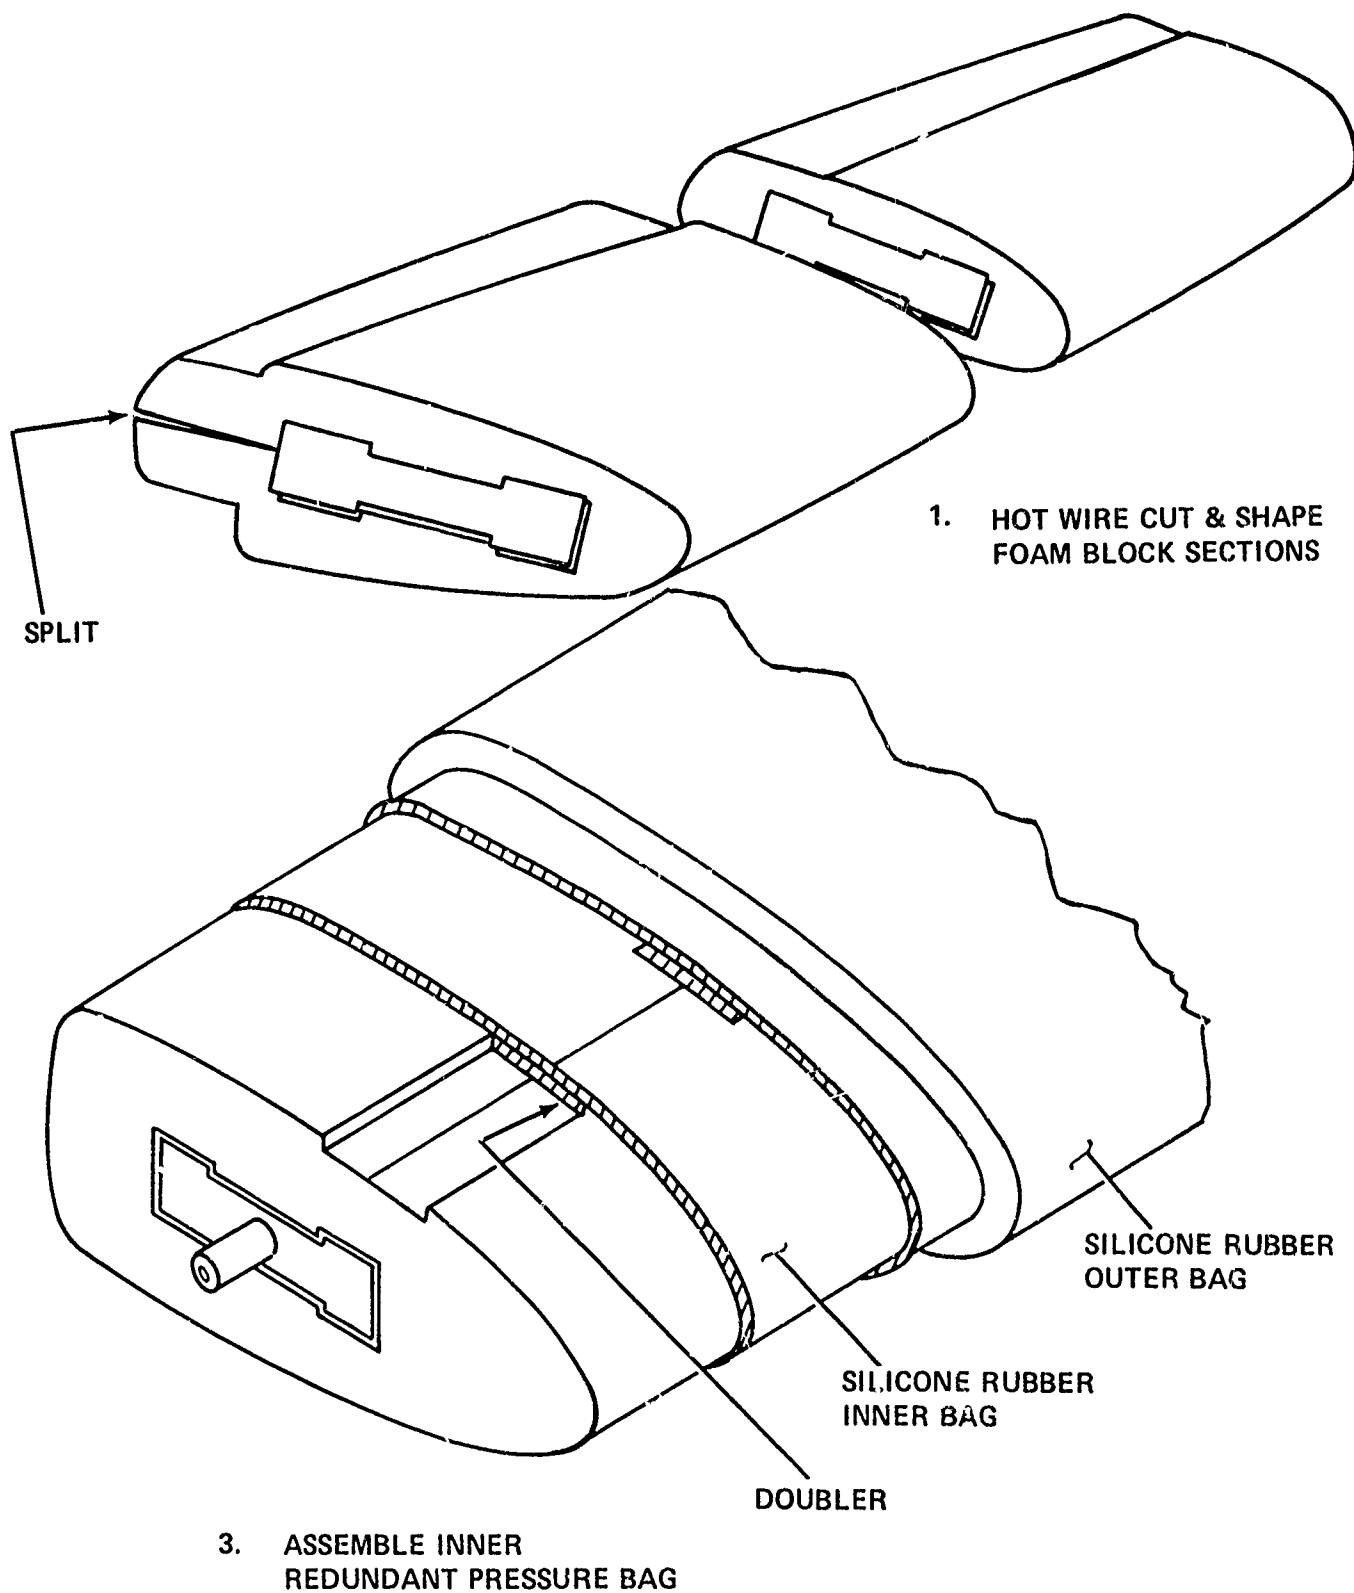
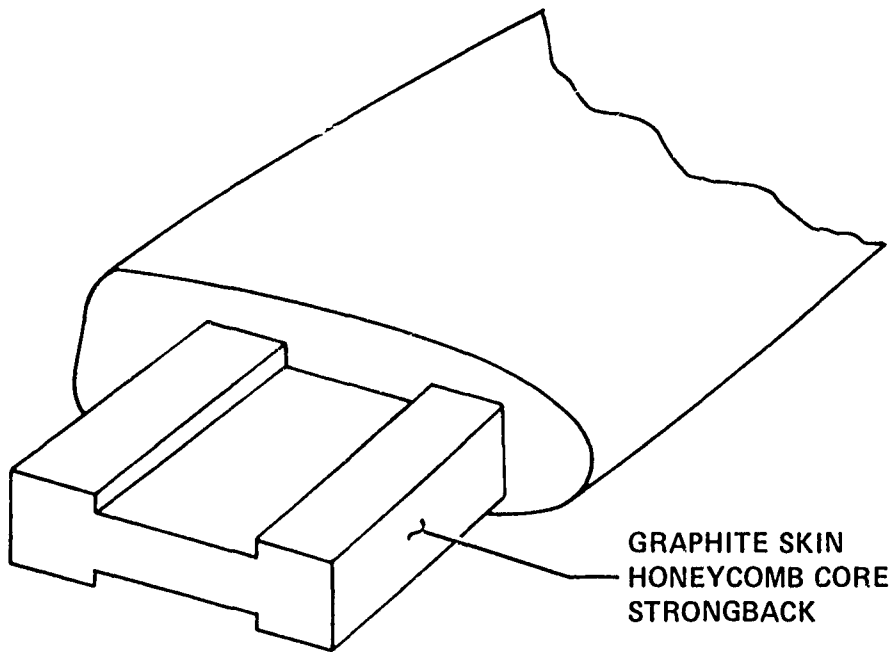
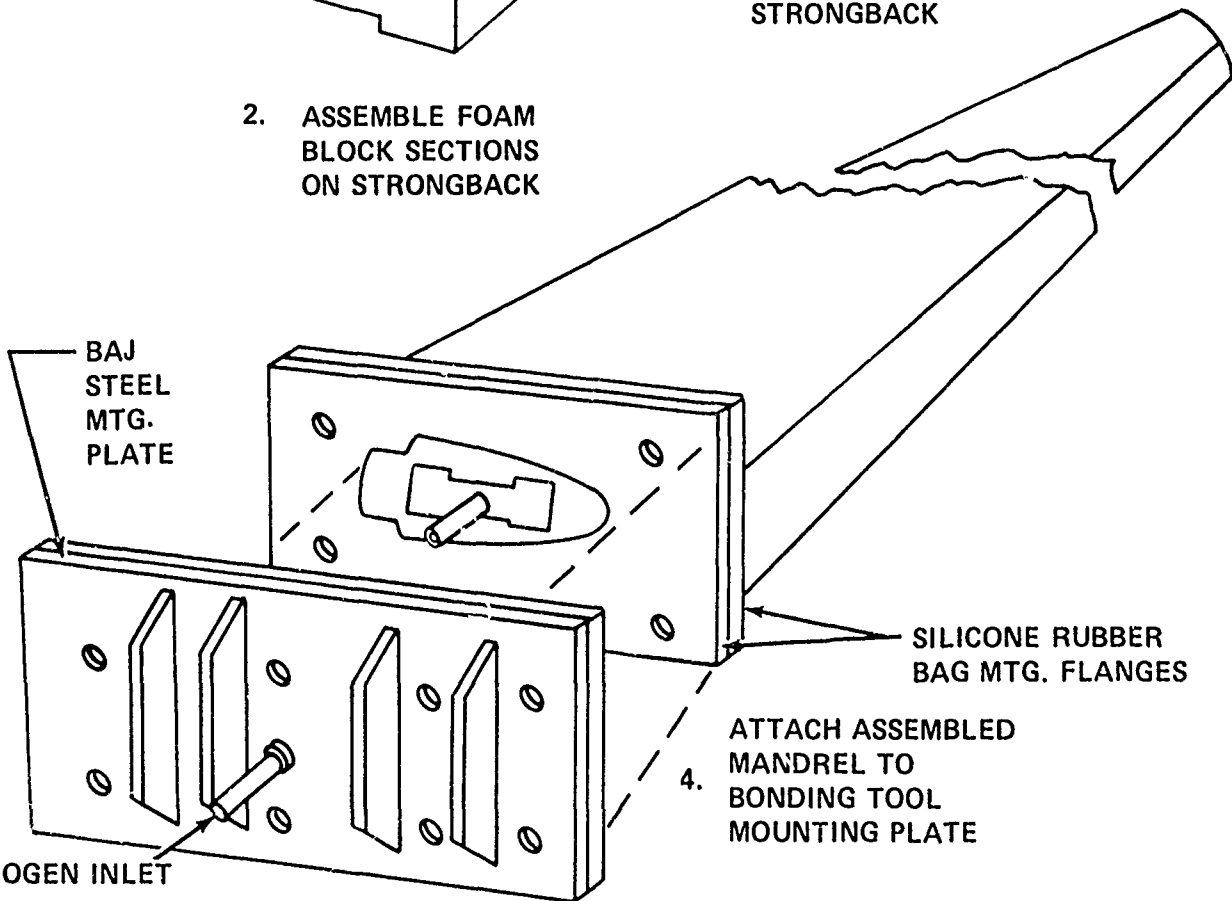
Figure 32. Internal Bag and Mandrel Fabrication Concept

After an analysis of other methods, the only other type of mandrel that merited consideration was one using styrofoam as a filler in place of the aluminum balls. In this type of mandrel, the foam blocks which are approximately 16 in. long are cut using a template at each end to produce the correct contour. (See Figure 32.) A "hot wire" cutting tool is used to cut the foam, which produces a smooth surface. The foam blocks are then assembled on a strongback which maintains their alignment and permits handling the finished mandrel without excessive bending. Two silicone rubber bags are then fabricated on the foam blocks or reassembled on the foam blocks if they have been used before. Two bags are used, each 0.06 in. thick and one on top of the other, thereby giving a safety factor should one bag fail during the cure. In past programs of this type, bag failures were quite common and costly, so every effort was taken to try to improve on bag design. It should be noted that throughout the eight-blade ATC Program no spars were lost due to bag failure. After assembly of the rubber bags over the foam blocks and strongback (Figure 33), the bags were sealed and a vacuum was pulled.

2. ASSEMBLE FOAM  
BLOCK SECTIONS  
ON STRONGBACK

4. ATTACH ASSEMBLED  
MANDREL TO  
BONDING TOOL  
MOUNTING PLATE

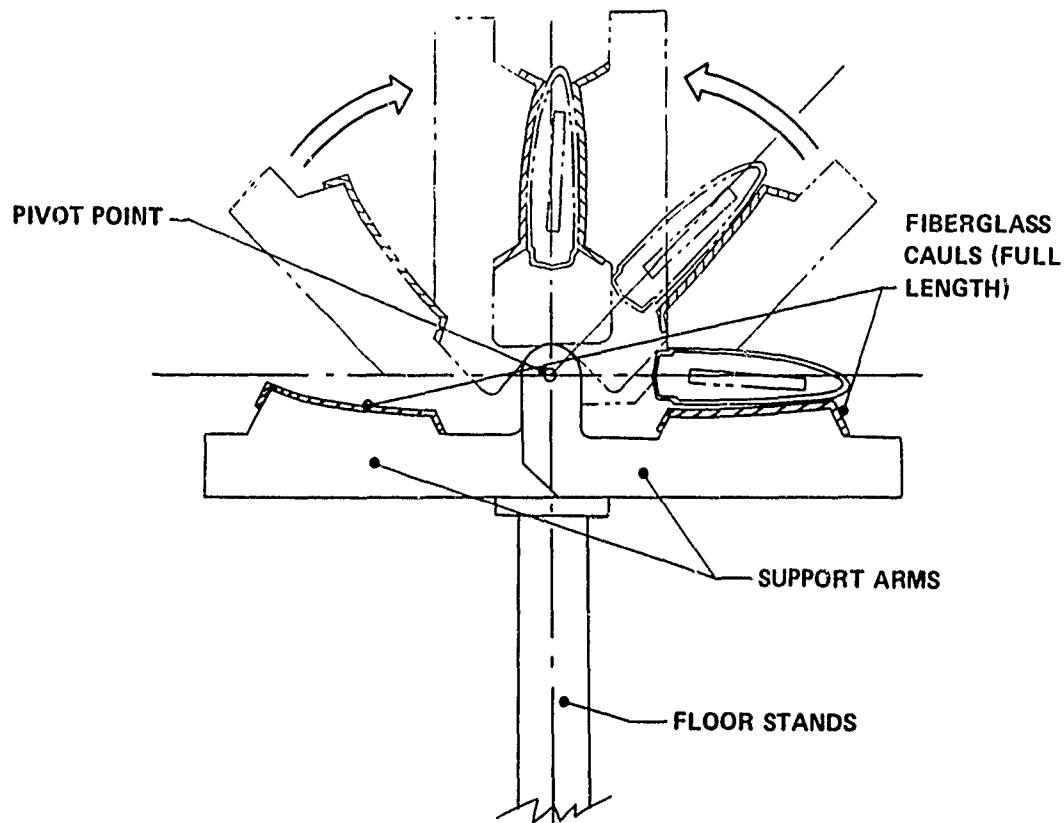
*Figure 34. Operation of Spar Assembly Support Stand*

**1ST POSITION: STEP 1**

LAYUP INNER TORSION WRAP (UPPER AIRFOIL)  
LAYUP SPAR STRAPS  
LAYUP OUTER TORSION WRAP

**STEP 2**

SWING SUPPORT ARMS  
TO VERTICAL POSITION

the following functions. Refer to Figures 34, 35, and 36.

After the spar lay-up has been completed (Figure 34), the titanium nose cap is located on the spar assembly, and the complete assembly is installed into the lower half of the Spar Bonding Fixture (BAJ SK301-11173-1). Refer to Figures 37, 38, and 39. The design of the spar bonding fixture used six castings; the lengths of these castings were determined primarily by the airfoil changes. (See Figure 40.) It could be seen that this would provide the greatest flexibility for change if, in the future, airfoil changes would be required. The casting breaks occur at Stations 66, 138, 220.8, 276, 372, 469.2 and 565.8; this allows 13.8 inches excess at the tip for quality control test pieces. The material selected for castings was Meehanite Type HS since it compares favorably from a strength standpoint with any heat resisting metal and is recommended for application at temperatures far above the HLH 250°F requirement under conditions of both cyclic and continuous heating without thermal shock. It machines easily and provides maximum resistance to scaling and growth. Thermal expansion of Meehanite HS is more compatible with fiberglass than most metals. Meehanite would also minimize distortion of the mold during repeated heating and cooling. Castings were selected for use rather than weldments or hogouts since layouts indicated that all five outboard sections could be machined from castings made from one basic pattern with removable inserts, resulting in a cost saving. A special pattern and casting was required for the root end section (Stations 66 to 138).

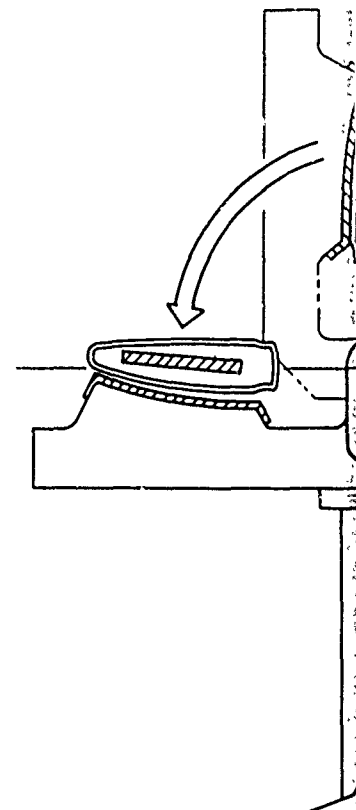
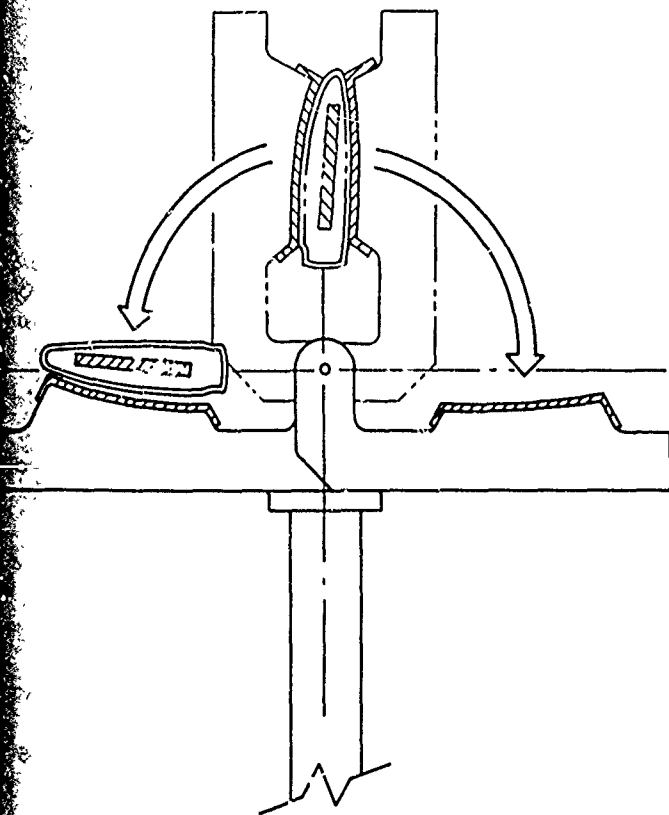
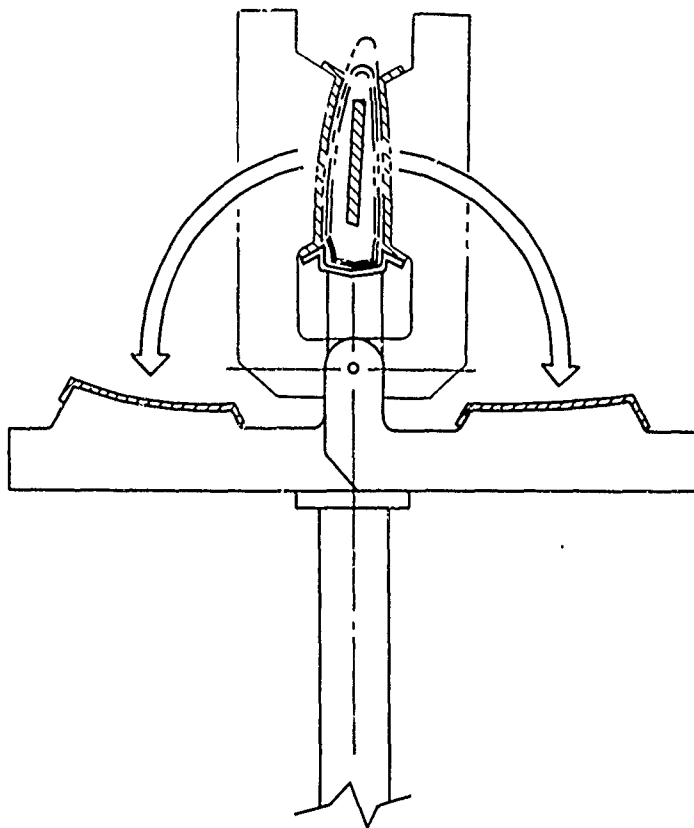
**2ND POSITION: STEP 1**

LAYUP INNER TORSION  
LAYUP SPAR STRAPS  
LAYUP OUTER TORSION

**STEP 2**

TRANSFER  
OPPOSITE  
SWING SL  
TO HORI

**POSITION: STEP 1**

LAYUP INNER TORSION WRAP (LOWER AIRFOIL)  
LAYUP SPAR STRAPS  
LAYUP OUTER TORSION WRAP

TRANSFER LAYUP TO  
OPPOSITE SIDE AND  
SWING SUPPORT ARMS  
TO HORIZONTAL

**3RD POSITION:**

ASSEMBLE TITANIUM CAP  
AND NOSE BLOCK ASSEMBLY

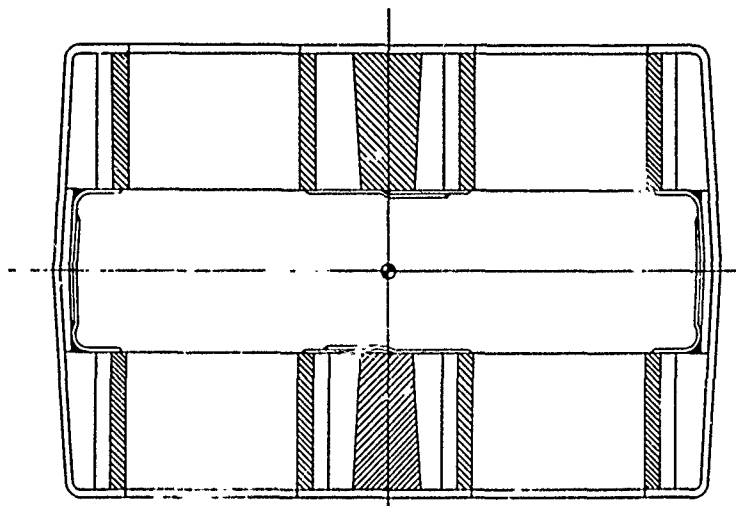
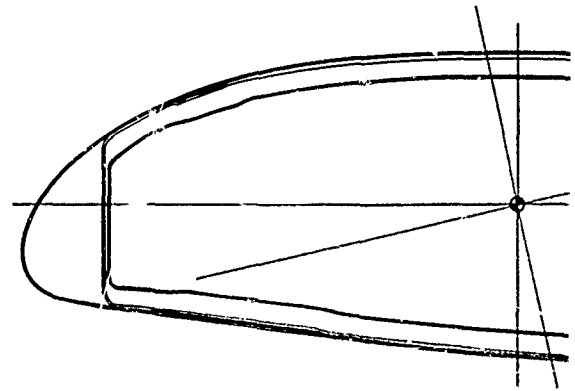
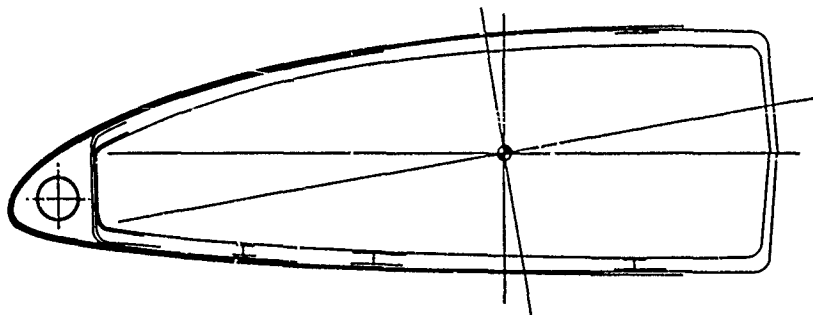
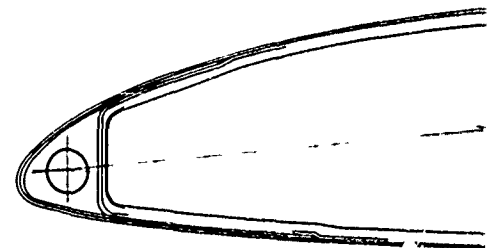
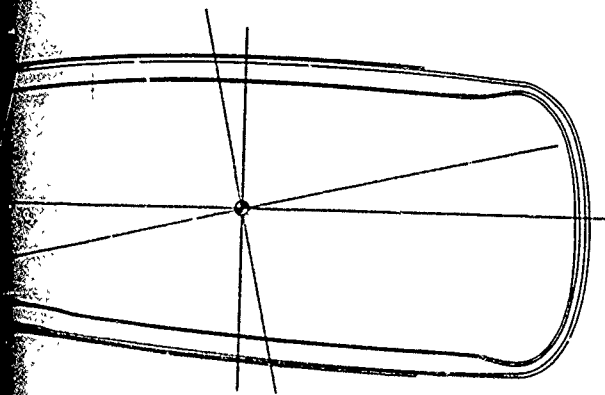
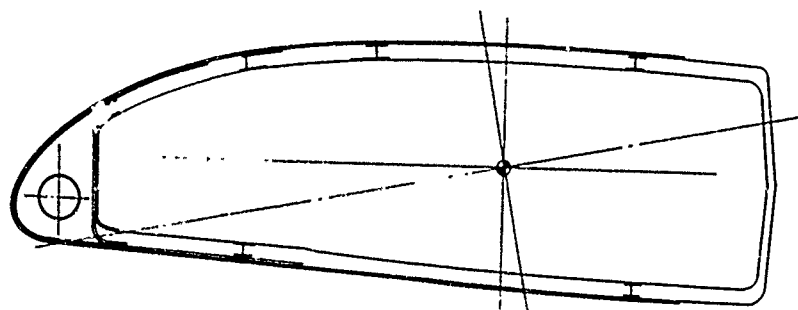
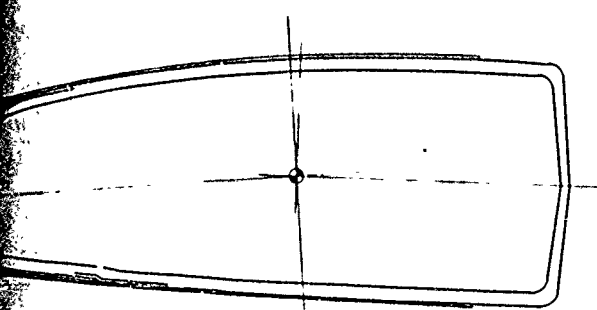
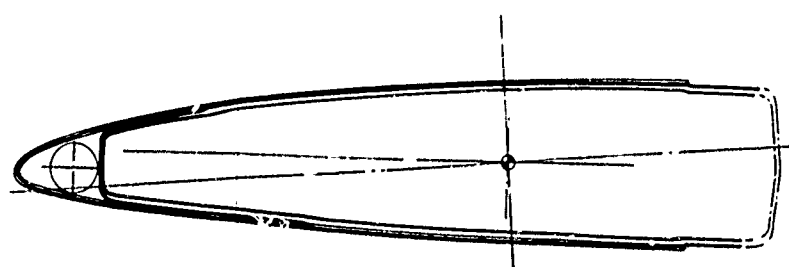
Figure 40. Spar Section Airfoil Transitions

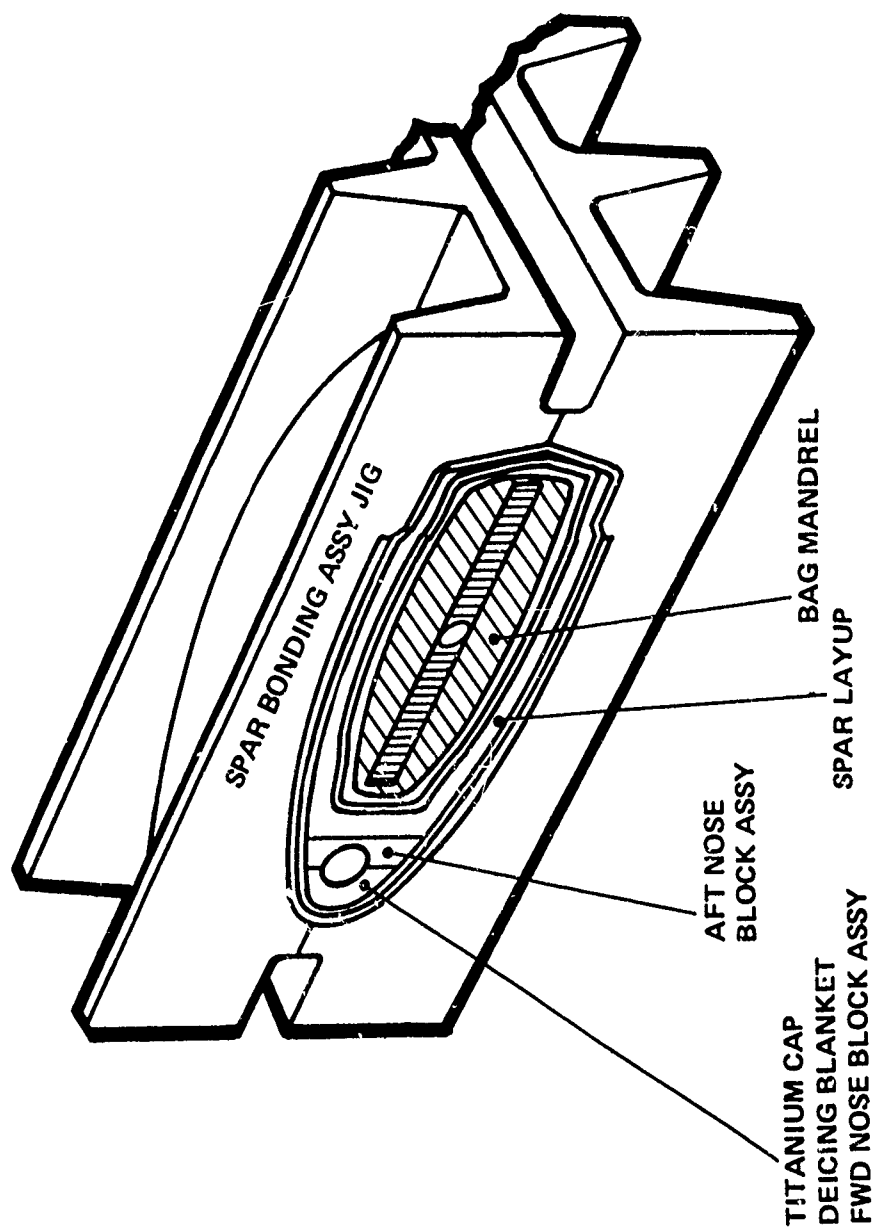
Figure 42. Spar BAJ Basic Theory Illustration

The basic premise of the spar tool application is to control the OML with the tool and to apply fluid pressure (80 to 100 psi) through the bag mandrel to the inside of the spar. Refer to Figure 42.

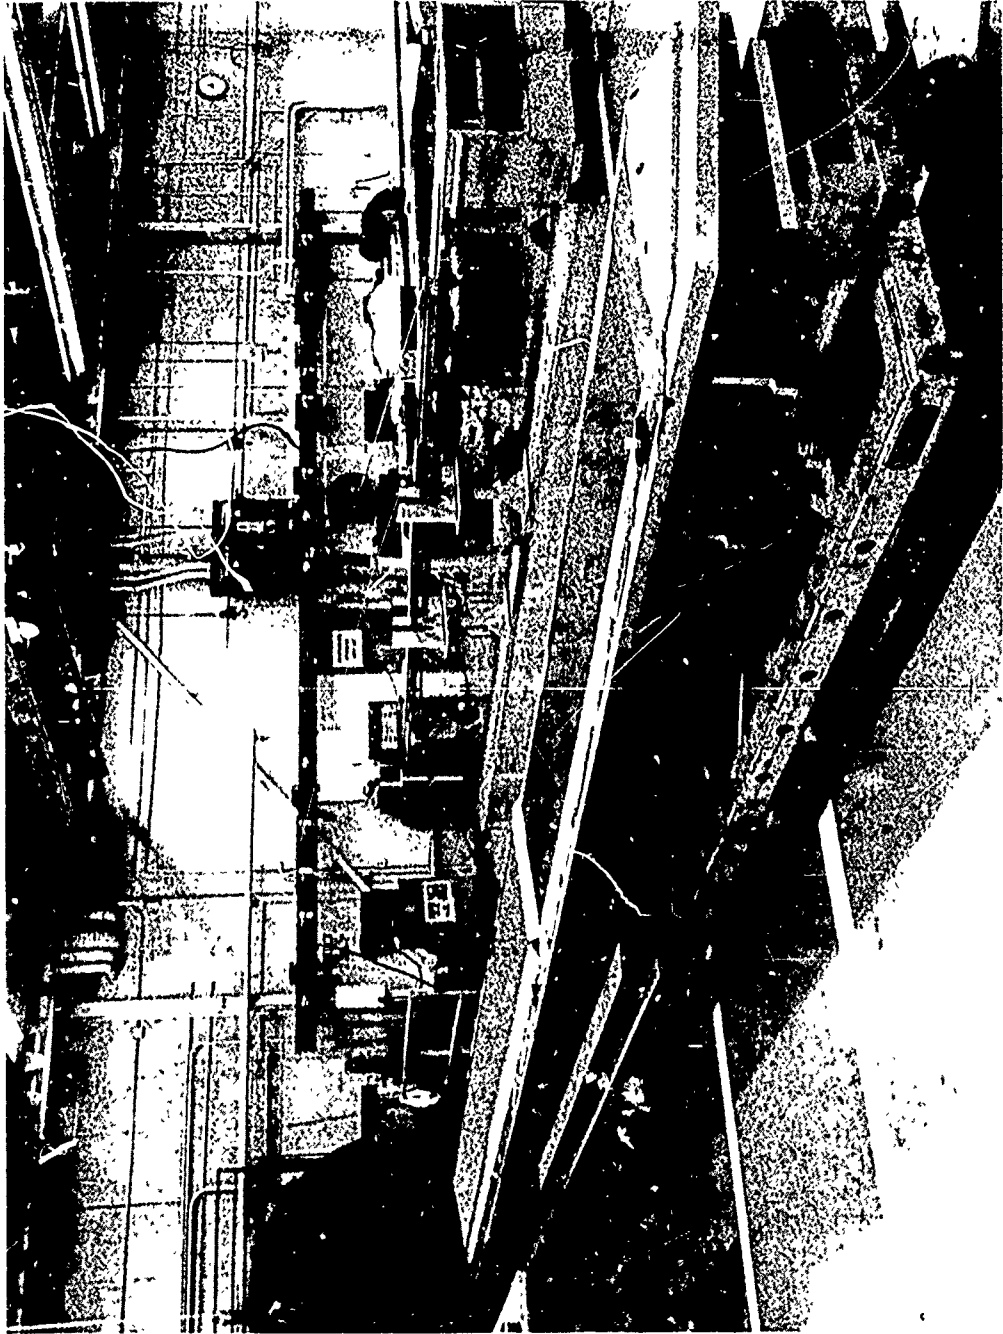
Figure 43. Vacuum Forming Mold, SK301-11179-1

1. Using the VFM (Figure 43), special adapters were installed at the trailing edge area in which the T.E. wedge was to be layed up and cured (Figure 44).
2. Removing the special adapters, the VFM was then used to bond the honeycomb core blocks to the T.E. wedge.
3. The one skin (lower airfoil skin) was layed up, cured, and bonded to the T.E. and core assembly (Figure 45).

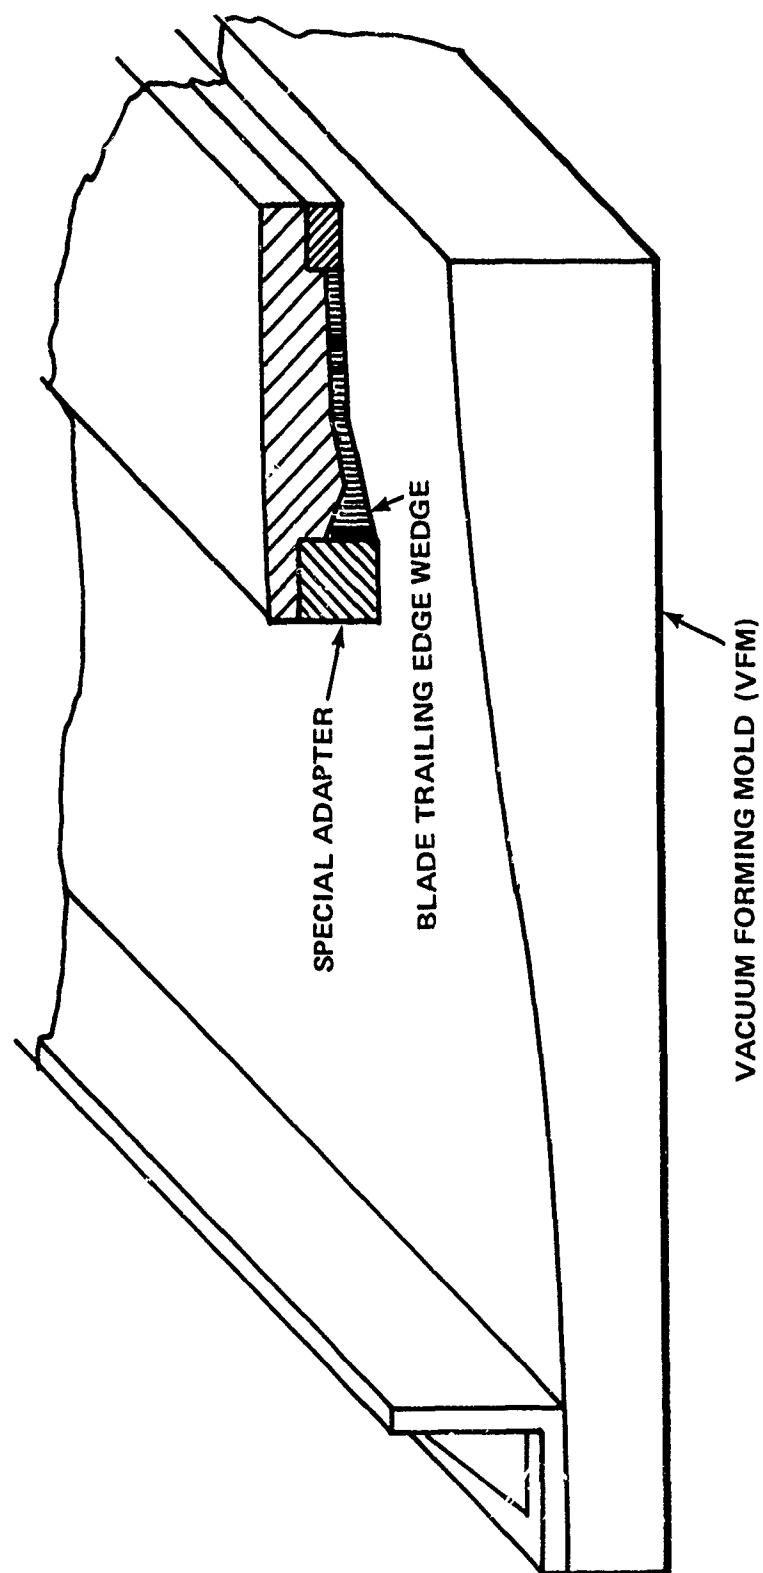
Figure 44. Special Adapter for VFM Used During Trailing Edge Wedge Fabrication

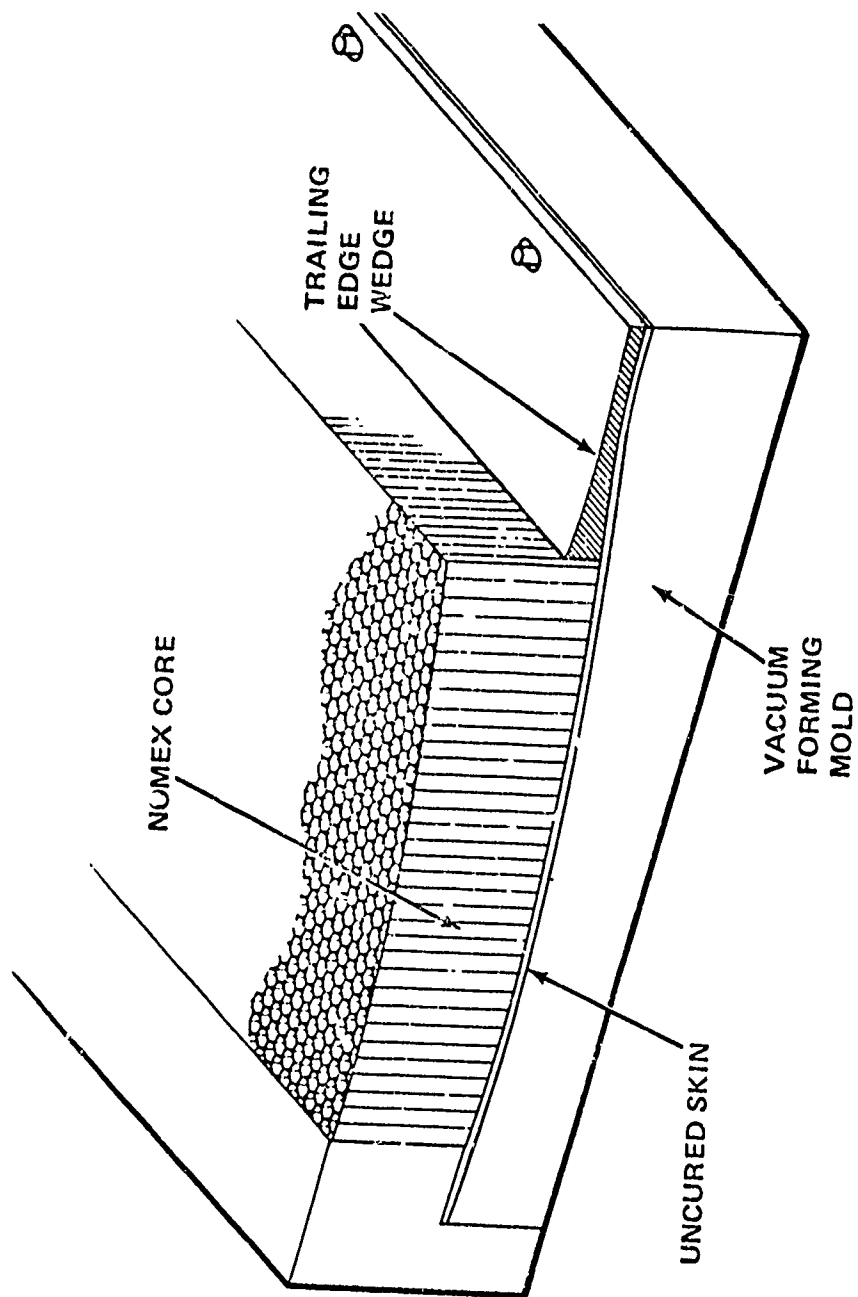
Figure 45. Lay-Up, Cure, and Bonding of Lower Skin to T.E. and Core Assembly

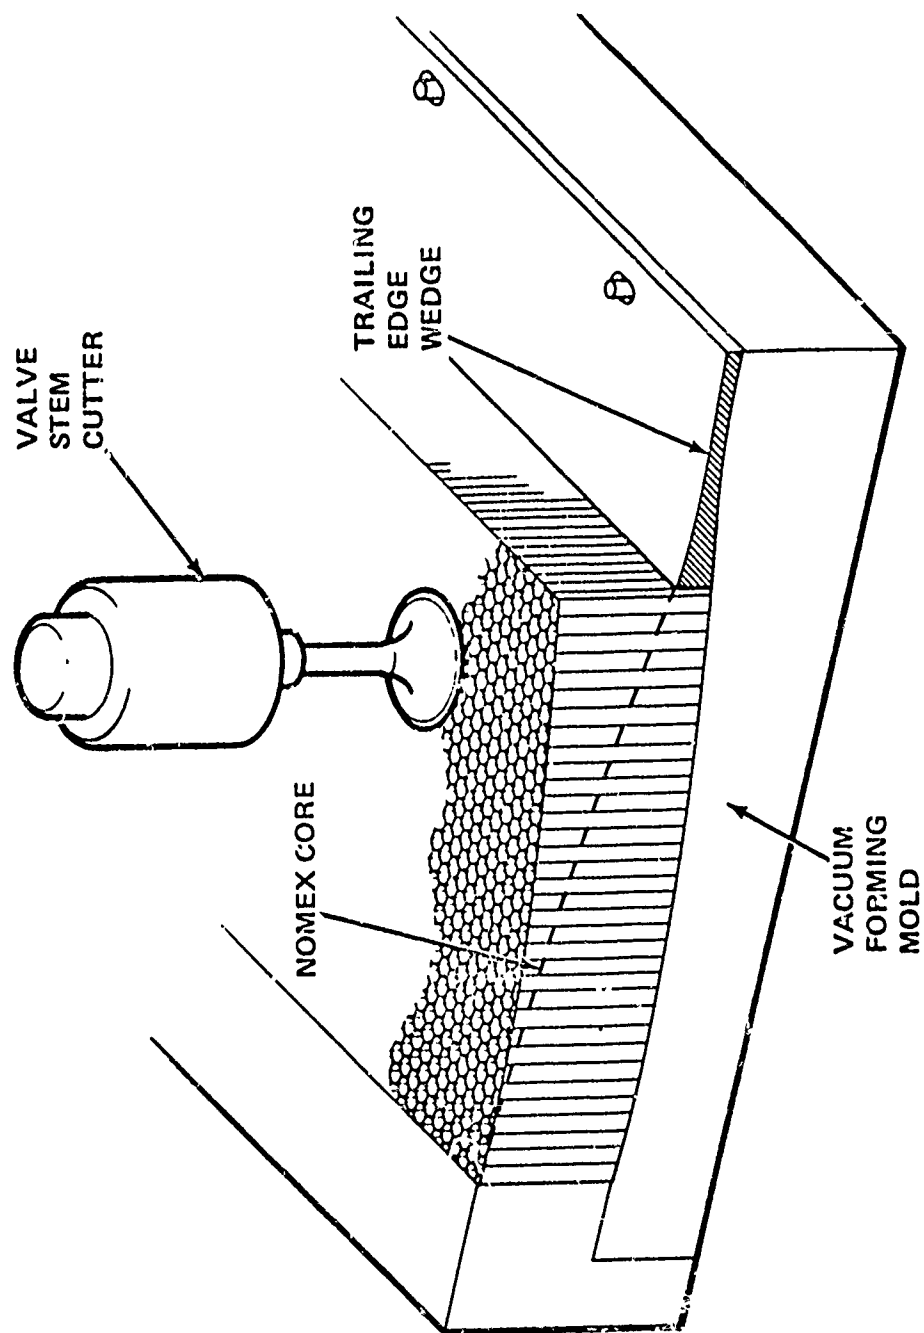
Figure 46. VFM Tool with Built-In Vacuum System Used for Machining Core

A second VFM tool was built for machining of core assemblies machined by a vendor. The only difference between this second VFM tool and the first was that the second unit had a vacuum system built into it for holding the core while it was being machined. (Figure 46)
